HOUSE OF BLUES

CASE STUDY

Boston Music Venue Turns up the Volume on ERV Maintenance

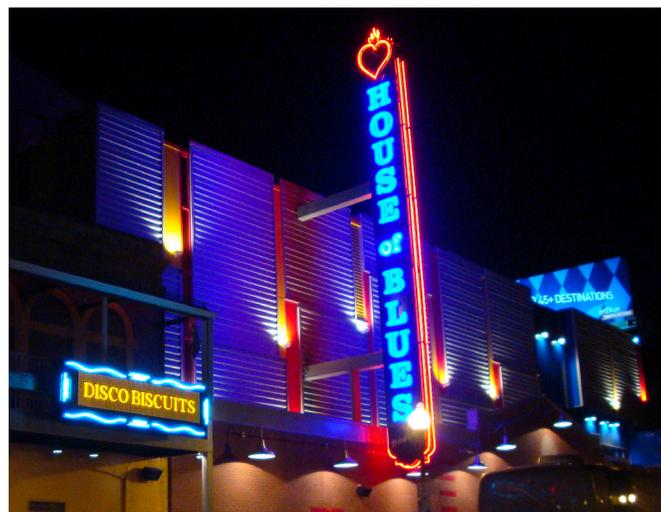
In 2016, energy recovery wheels in two rooftop air-handlers became blocked after six years of exposure to airborne particulates. Although efforts were made to unclog the damaged wheels, cleaning in place was not an option due to concerns that water and cleaning fluids could damage the ductwork and ceilings below.

Cullen's engineers knew from past experience that simply replacing the wheels without solving the cleaning problem would invite the same undesirable maintenance situation. At House of Blues, airborne particles from the large crowds, special effects vapors, and confetti would continue to clog the new wheels if the energy

transfer matrix could not be periodically maintained. When selecting replacement wheels, Cullen prioritized both ease of installation and the ability to clean or replace the energy recovery matrix once the units were in operation. As they've done in the past, Cullen chose Airxchange Aftermarket replacement energy recovery wheels as the best solution moving forward.

Airxchange offers a unique wheel design that allows a single person to remove pie-shaped energy transfer segments with basic hand tools to be cleaned outside of the cabinet. The refresh-capability of Airxchange wheels means that they can be cleaned as often as the application dictates and counted on to last for the life of the HVAC system.

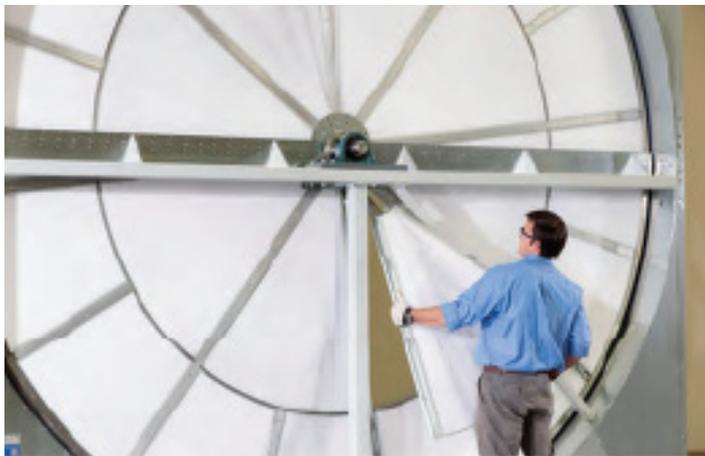
Because of constraints of the air-handler designs, which blocked the removal or installation of fully assembled wheels, Cullen selected replacement wheel kits from Airxchange. These replacement kits could be easily carried through the theater and up the stairs to be quickly assembled within the cabinet of the rooftop air-handling units.

The replacement wheels were fully assembled and tested at the factory before being partially dismantled to fit into the unique access points of the air-handlers. Once the old wheels were removed by the service contractor, the two Airxchange wheels were assembled inside of the cabinets in less than four hours.
